INSPECTION REPORT  
FOR  
BRIGHTON LANDFILL NO. 1  
Brighton, IL  
ILD980497671  
R05-8410-01C

June 25, 1986

SUBJECT: Illinois/R05-8410-01C/IL0386

Brighton/Brighton Landfill No. 1

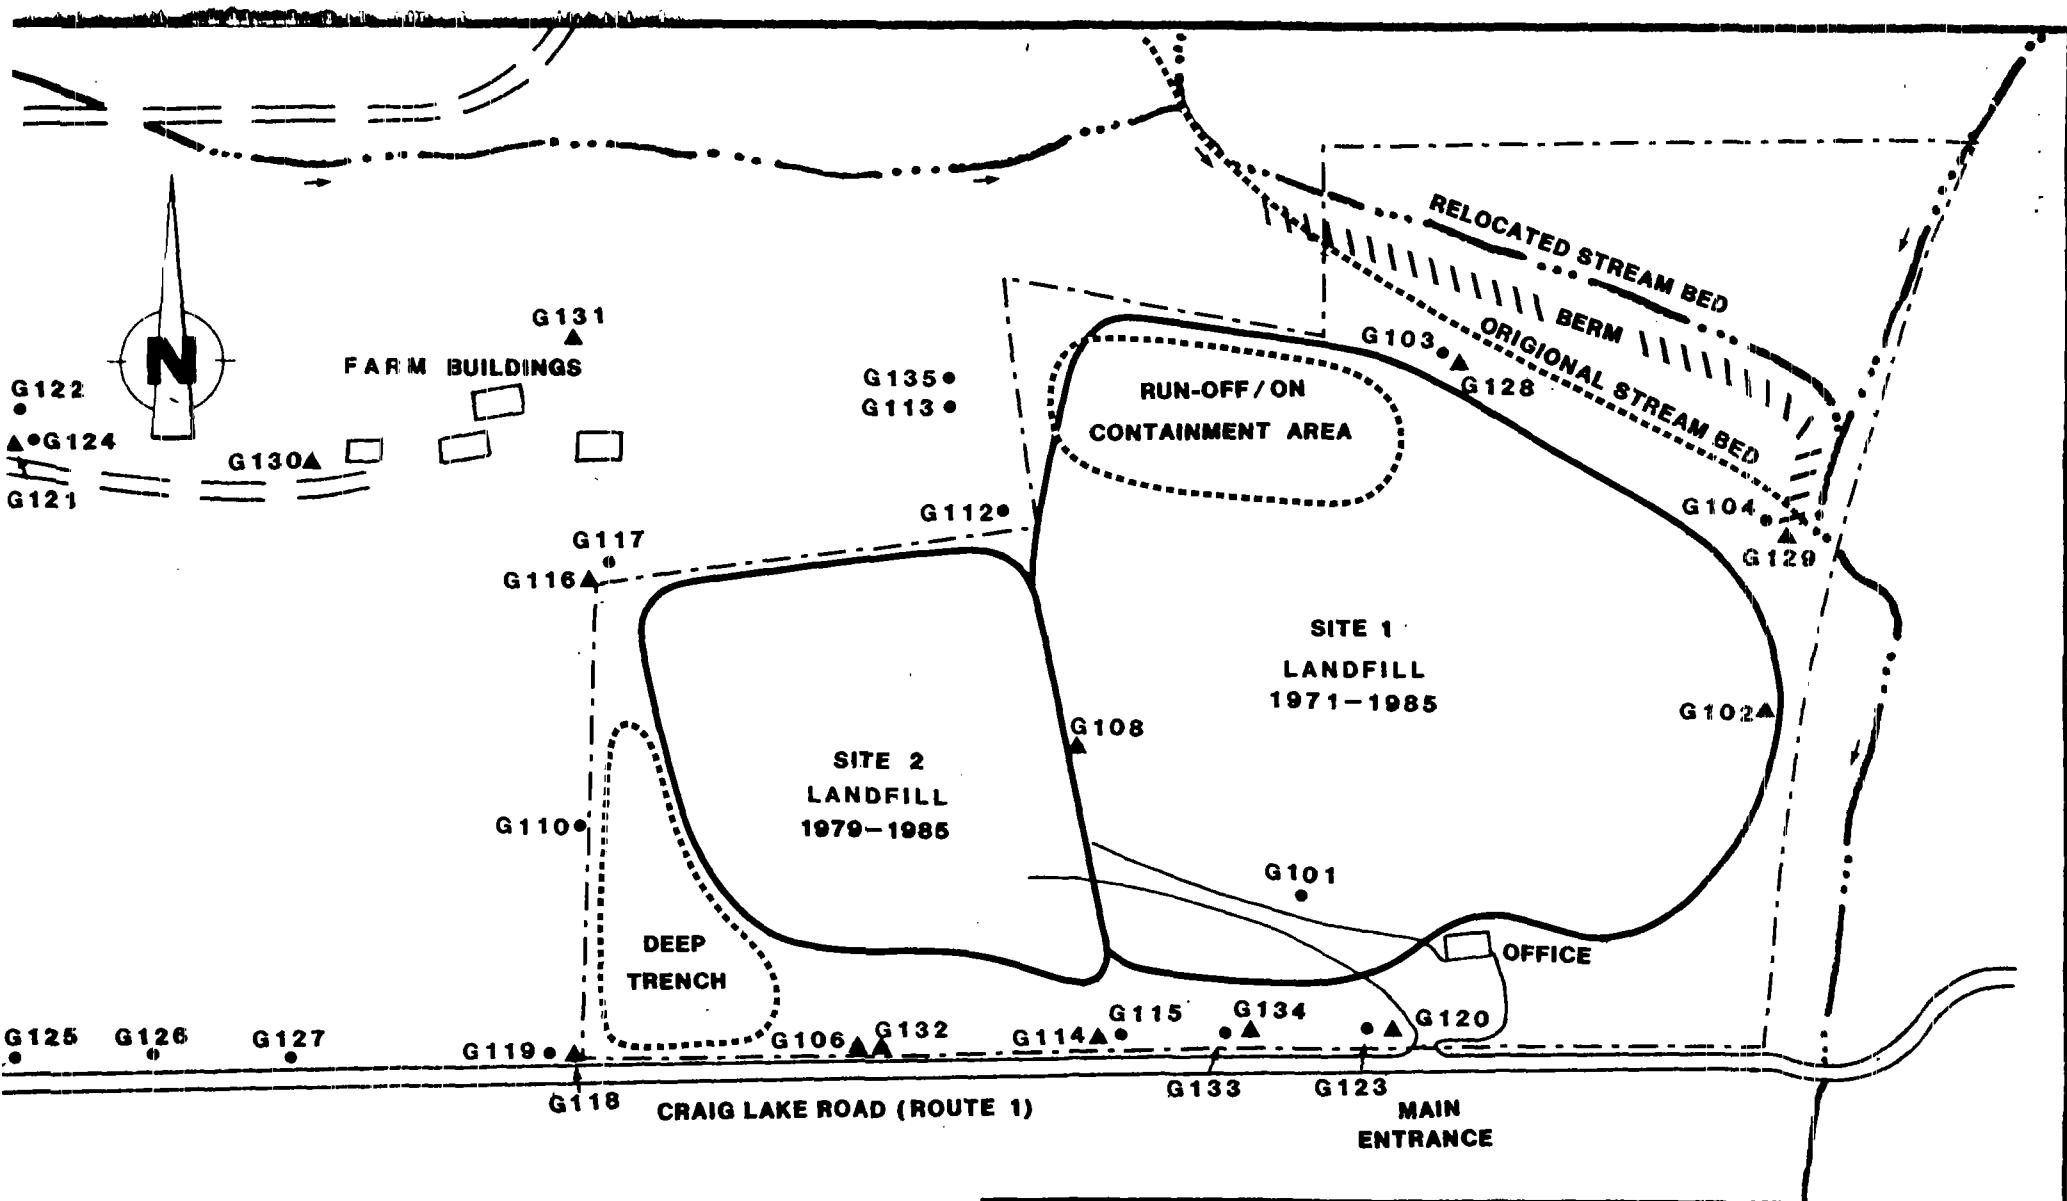
- ▲ SHALLOW WELL
- DEEP WELL

ecology and environment, Inc. 111 WEST JACKSON BOULEVARD CHICAGO, IL 60604		DRAWN BY GFH
SCALE: NONE	R05-8410-01C	REVISED
DATE: 6/30/86		
<b>MONITORING WELLS AND SITE FEATURES</b>		
<b>BRIGHTON LANDFILL</b>		DRAWING NUMBER

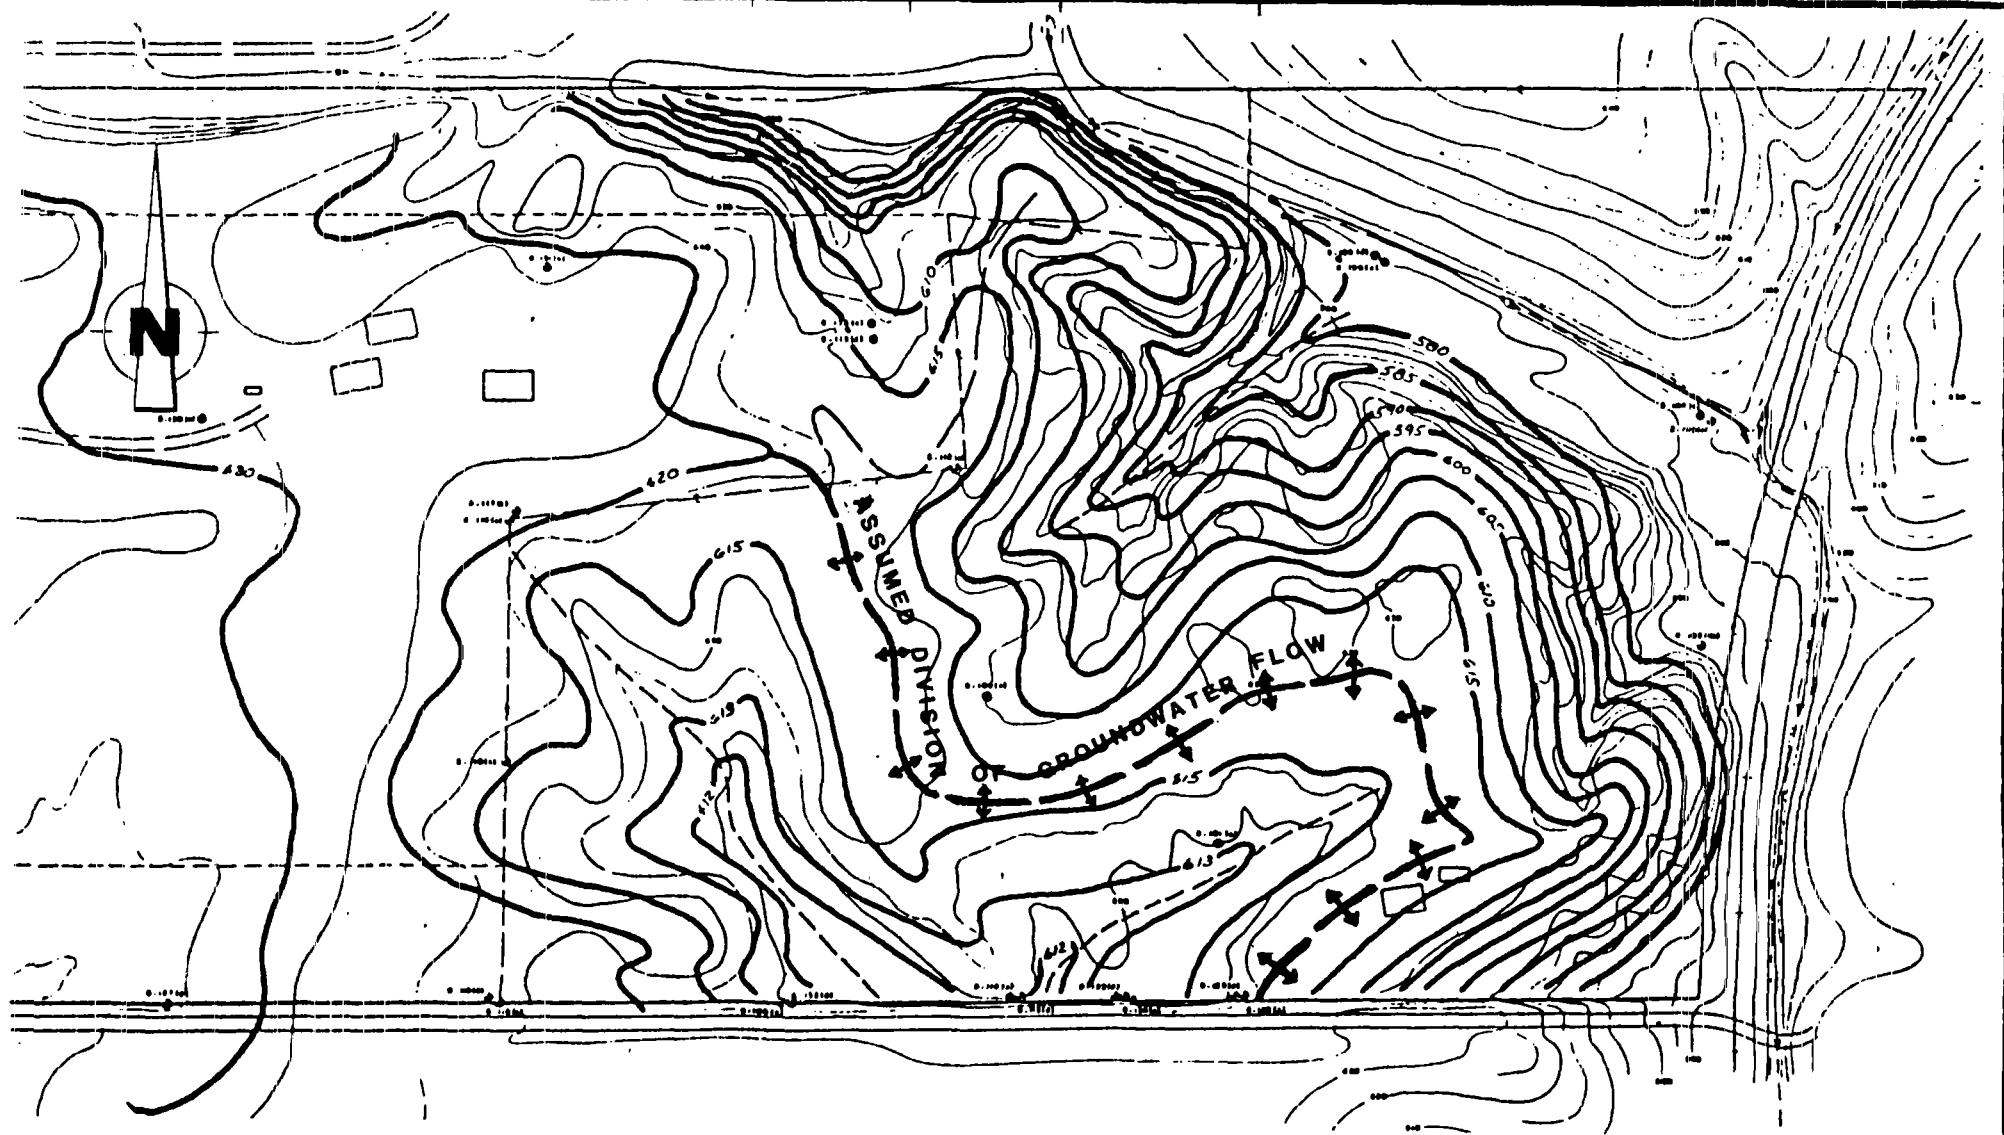
— 613 — Water Table Contour  
Line and Elevation

- Contour Interval as Shown
- Modified from Rapps Associates, Inc.

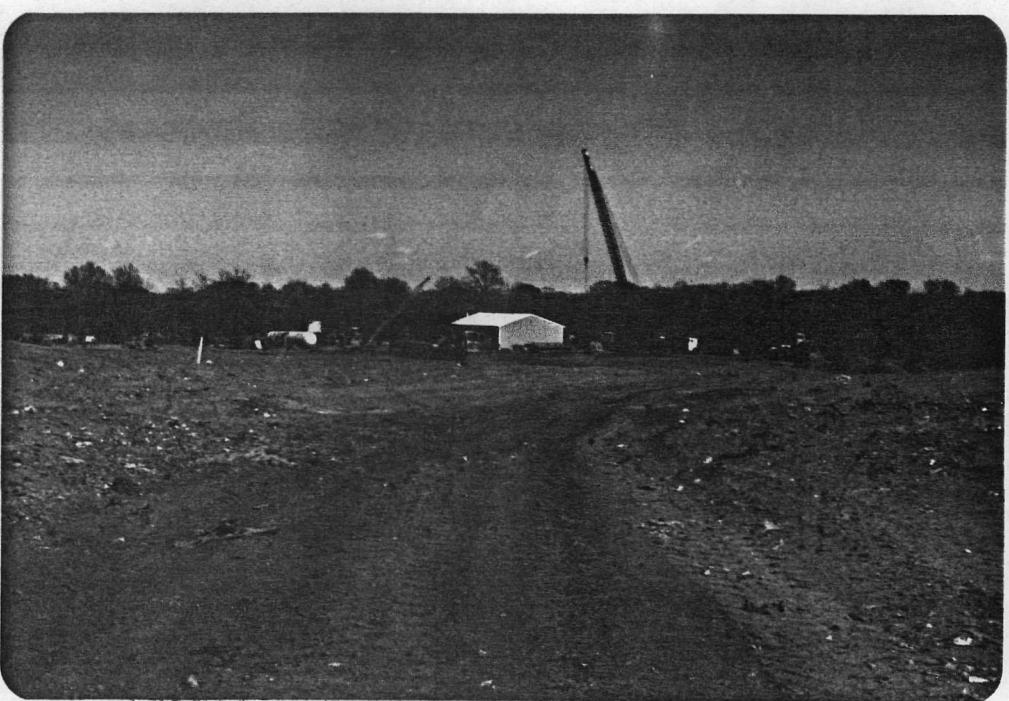
DESCRIPTION: View of site buildings from haul road on western portion of filled area.DATE 4/9/86TIME 1515 A.M. P.M.

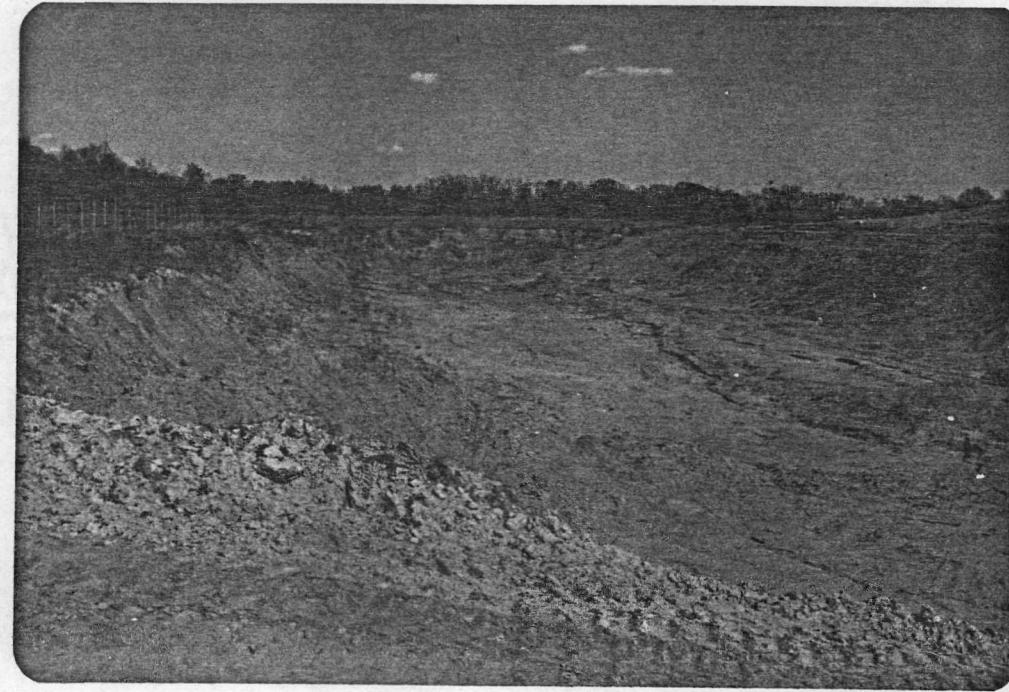
DESCRIPTION: View of surface water containment area located at N corner of site.

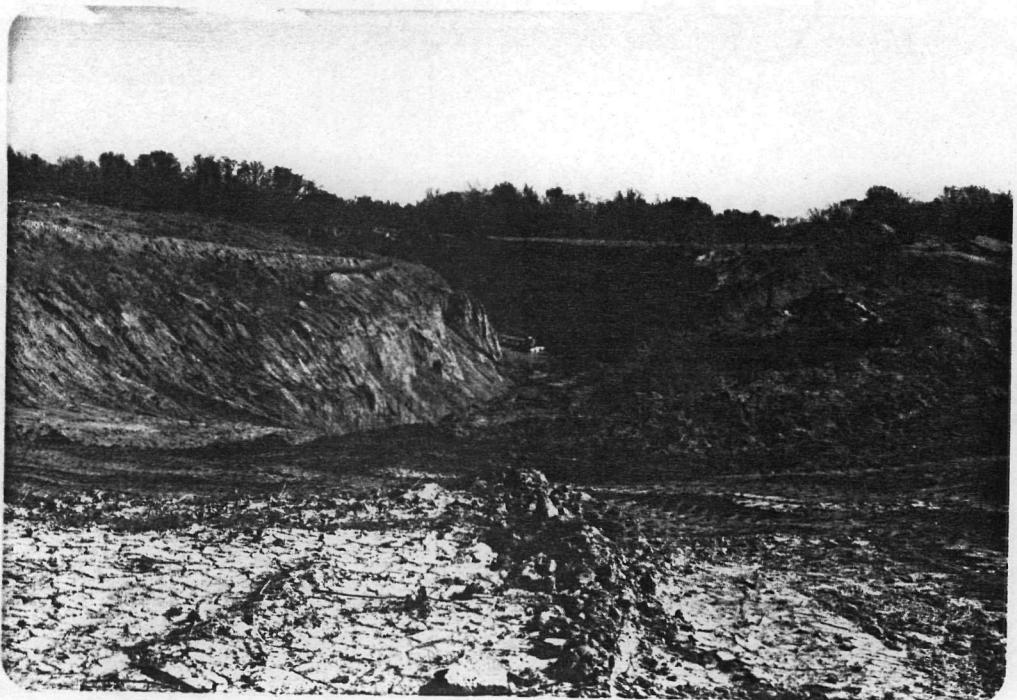
DESCRIPTION: View of deep trench constructed in South western to the Western side of landfill #2. Proposed for use as waste disposal trench

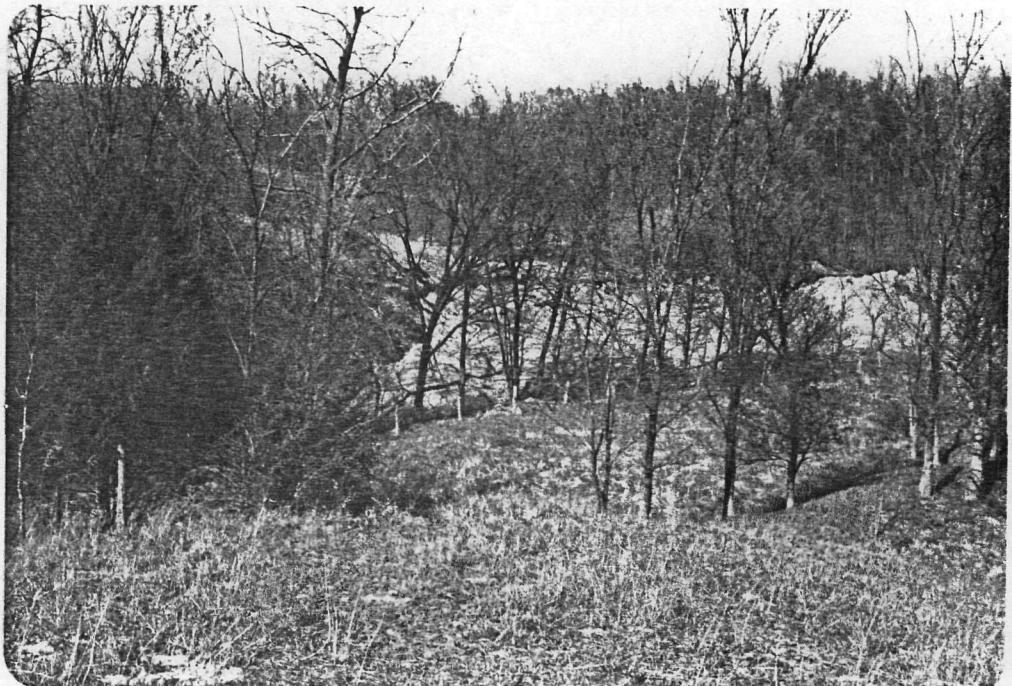
DESCRIPTION: View of creek relocation project. Creek flowing through Northeast side of site is being diverted to prevent erosion of fill and potential leachate contamination of creek.

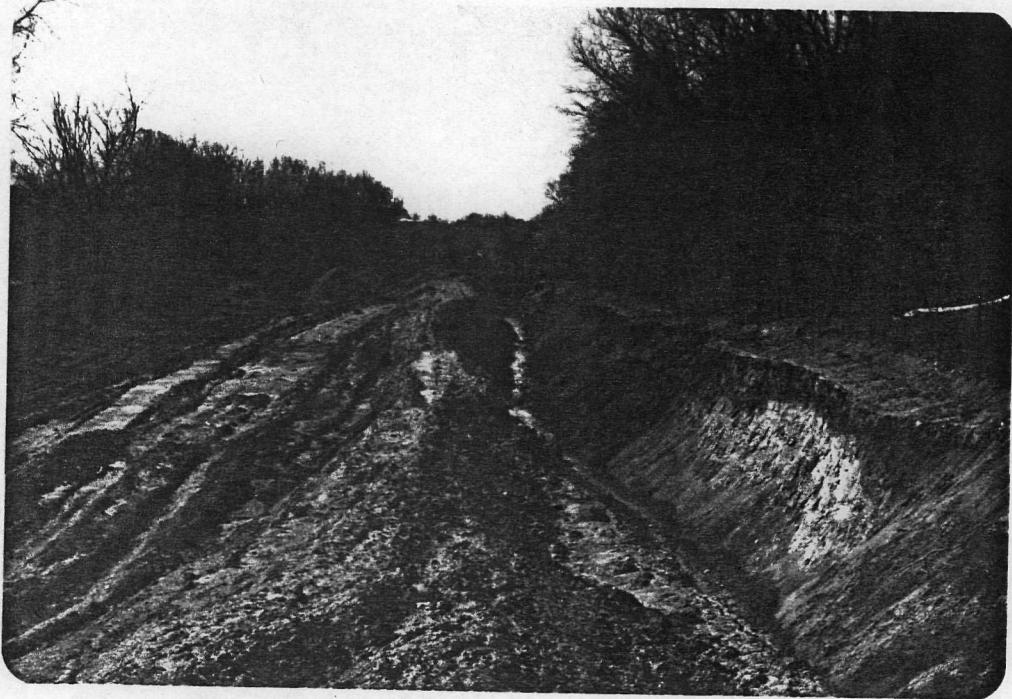
DESCRIPTION: Shows Berm along relocated section of creek. Old creek bed is visible along treeline in left side of photo. Note fence to the right of relocated stream bed.

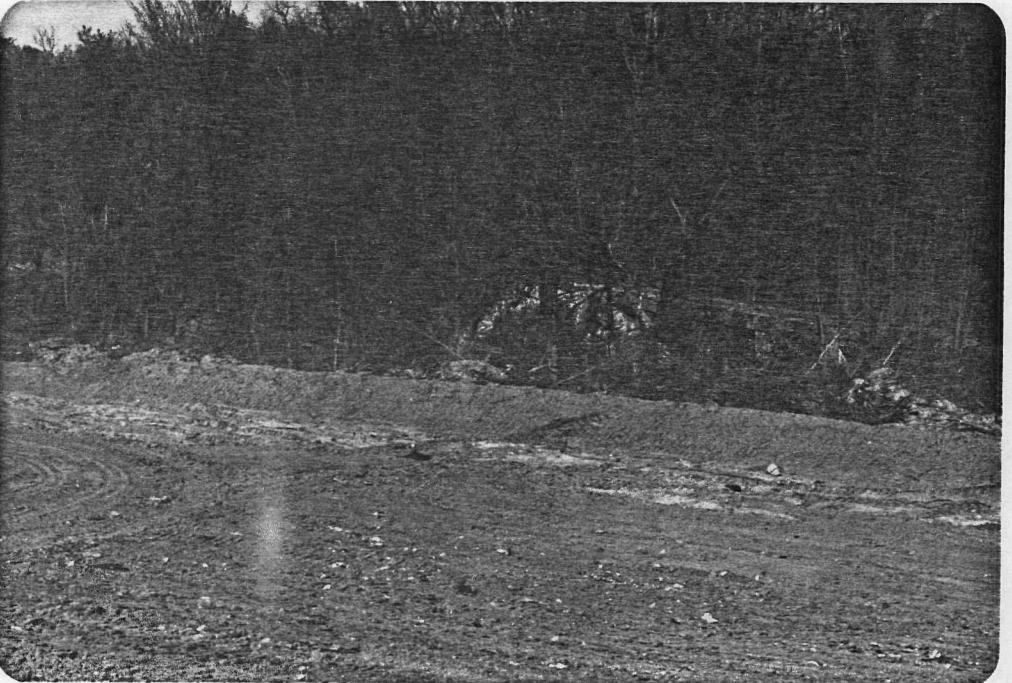
DESCRIPTION: View of creek as it leaves Northeast corner of site. Photo shows berm constructed along creek to prevent site runoff from entering stream.

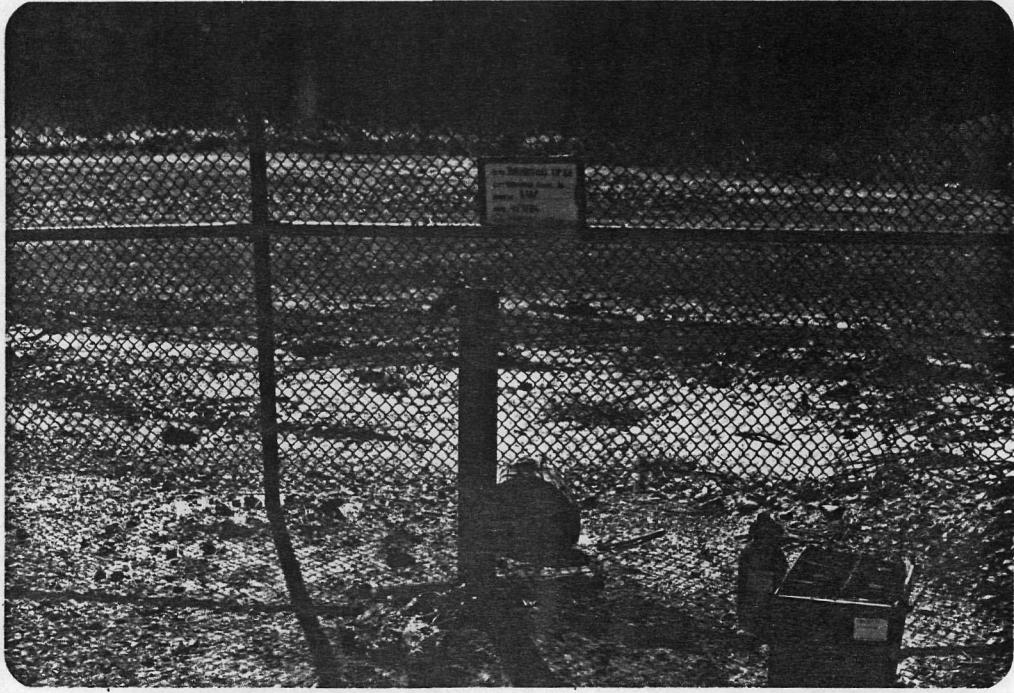
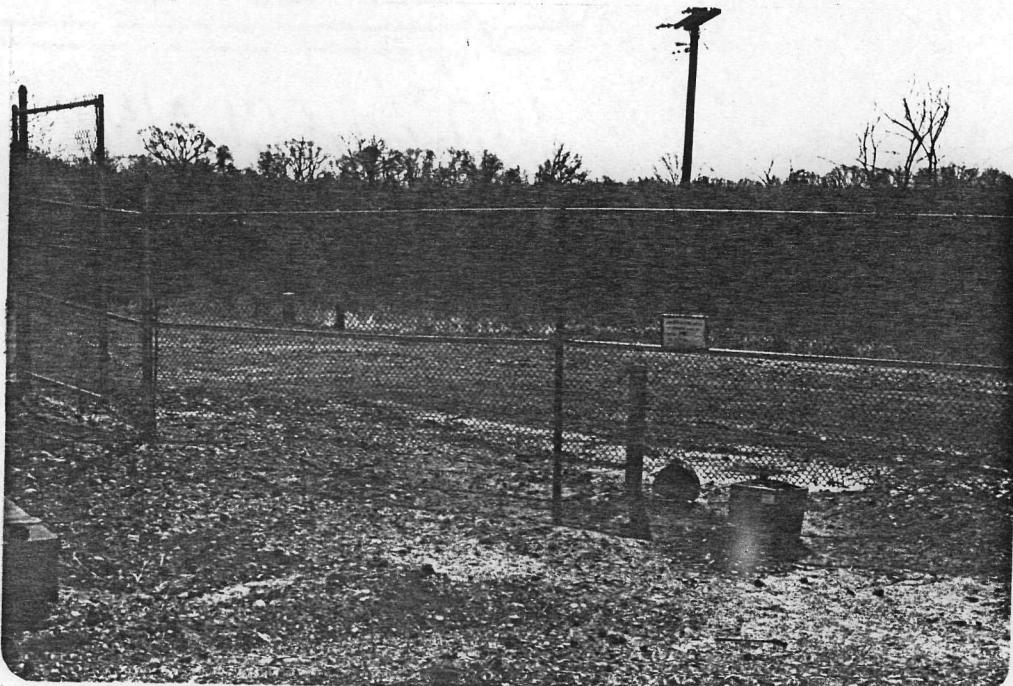
I W

DESCRIPTION: Photo shows well # 6123 d near site entrance.

DESCRIPTION: Same as above photo from ~20 ft.

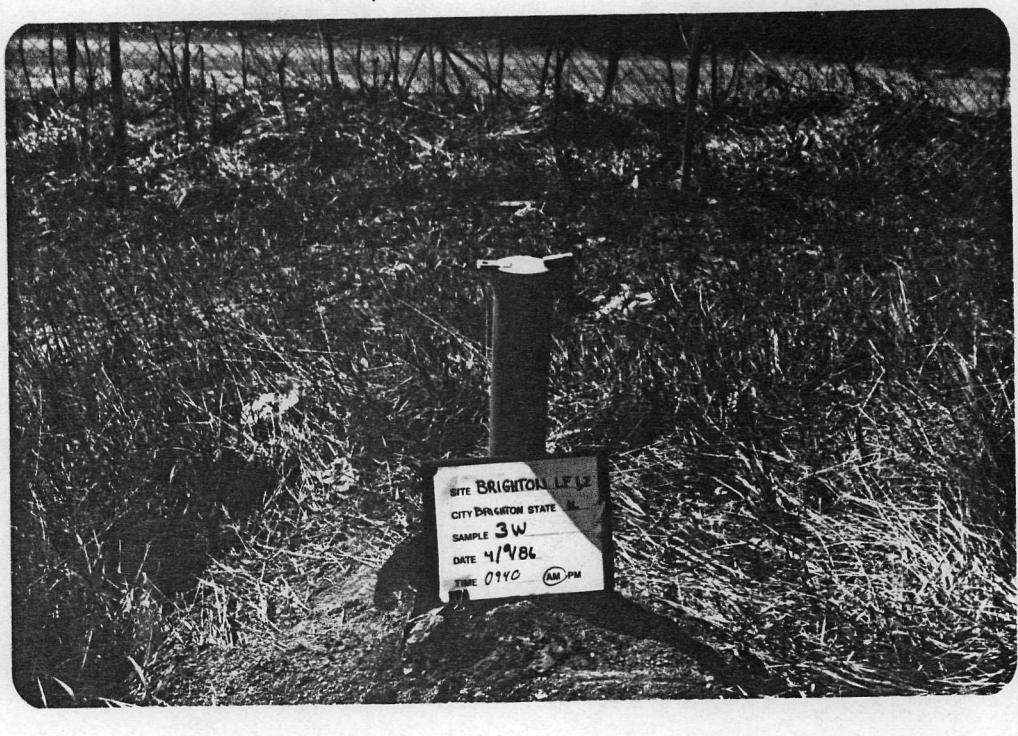
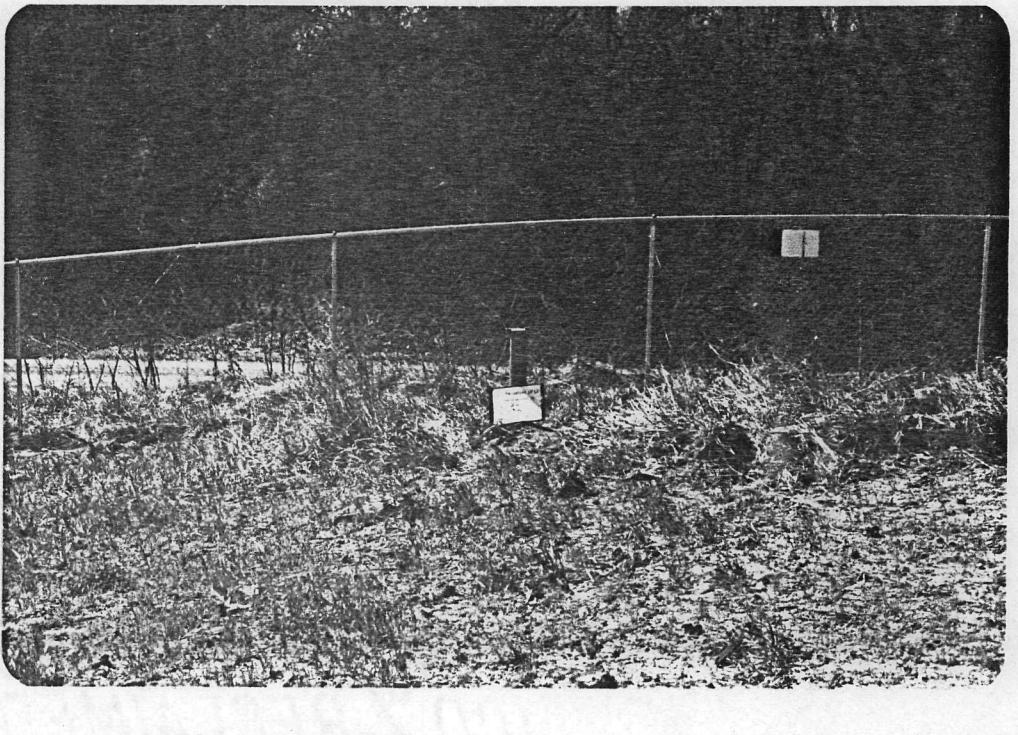
3W

DESCRIPTION: Well 61345 located along southern edge of site.

DESCRIPTION: Same as above from ~20 ft.

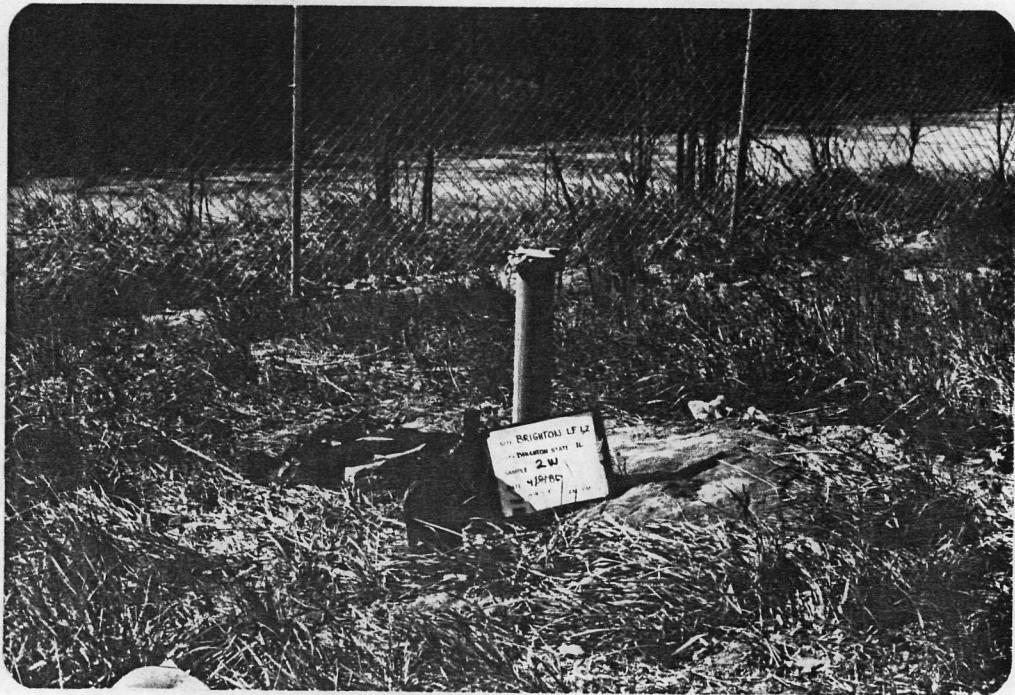
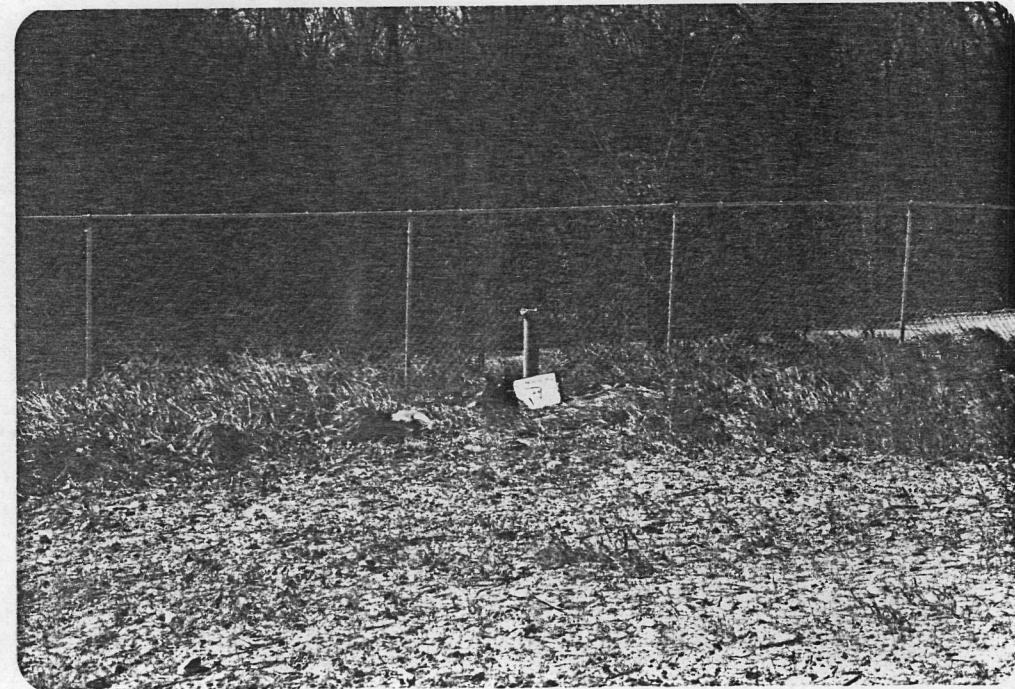
SAMPLE ID# (if applicable)  
2W

DESCRIPTION: Well G 133 d located along southern edge of site.DATE 4/9/86TIME 0935 A.M. P.M.

DESCRIPTION: Same as above from ~25 ft.

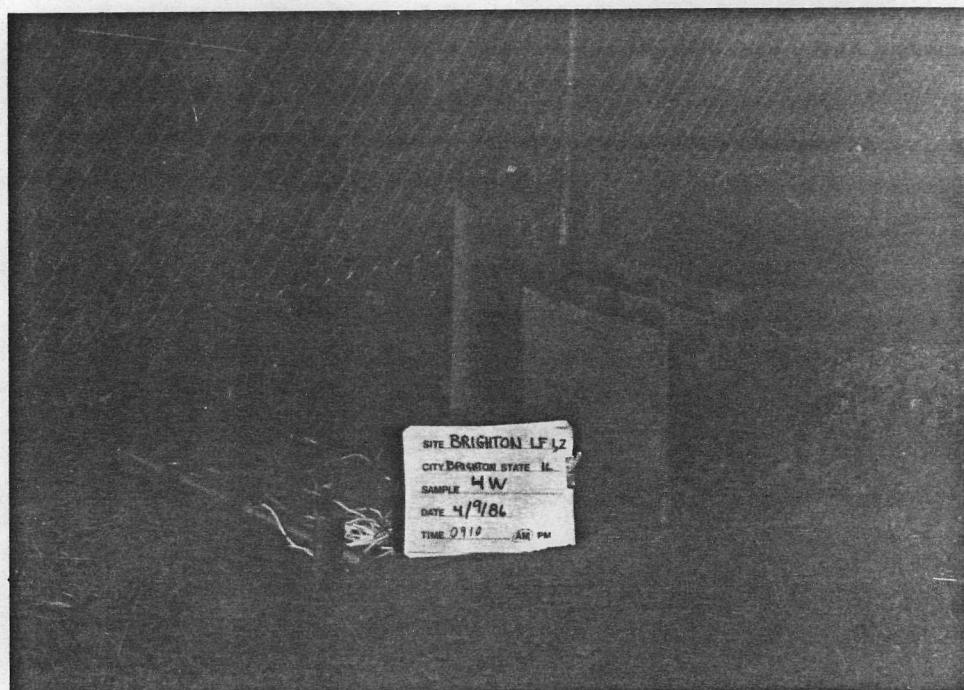
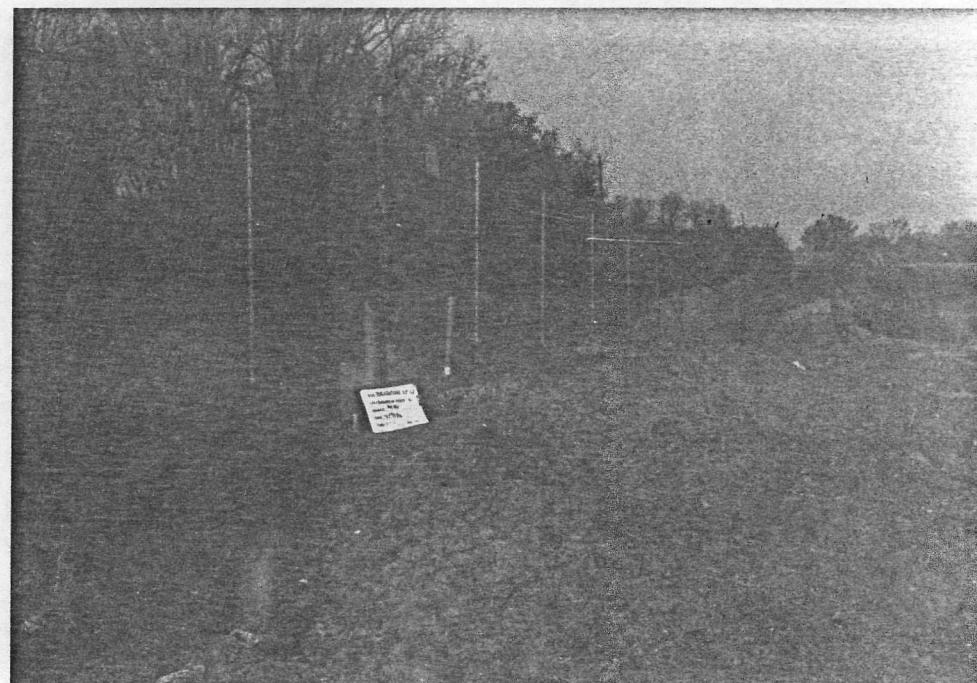
SAMPLE ID# (if applicable)  
4W

DESCRIPTION: Well # 6115 d located along southern site boundary.DATE 4/9/86TIME 0910 A.M. P.M.

DESCRIPTION: Same as above from ~ 20 ft.

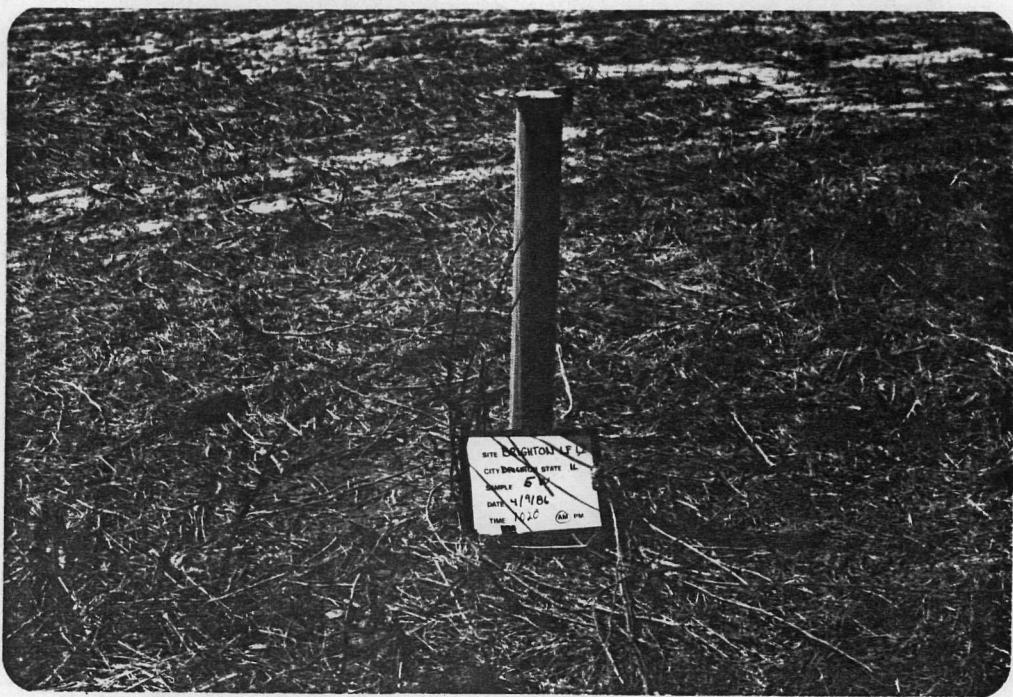
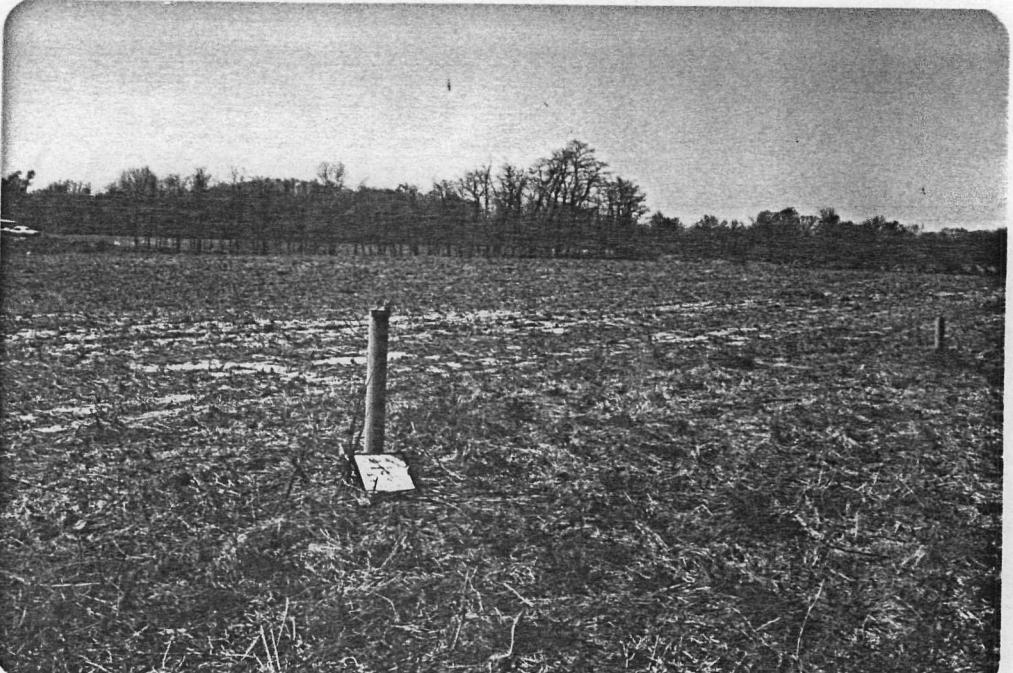
5 W

DESCRIPTION: Well #G 1 24 d located North west of site in farmed field.

DESCRIPTION: Same as above from - 20 ft.

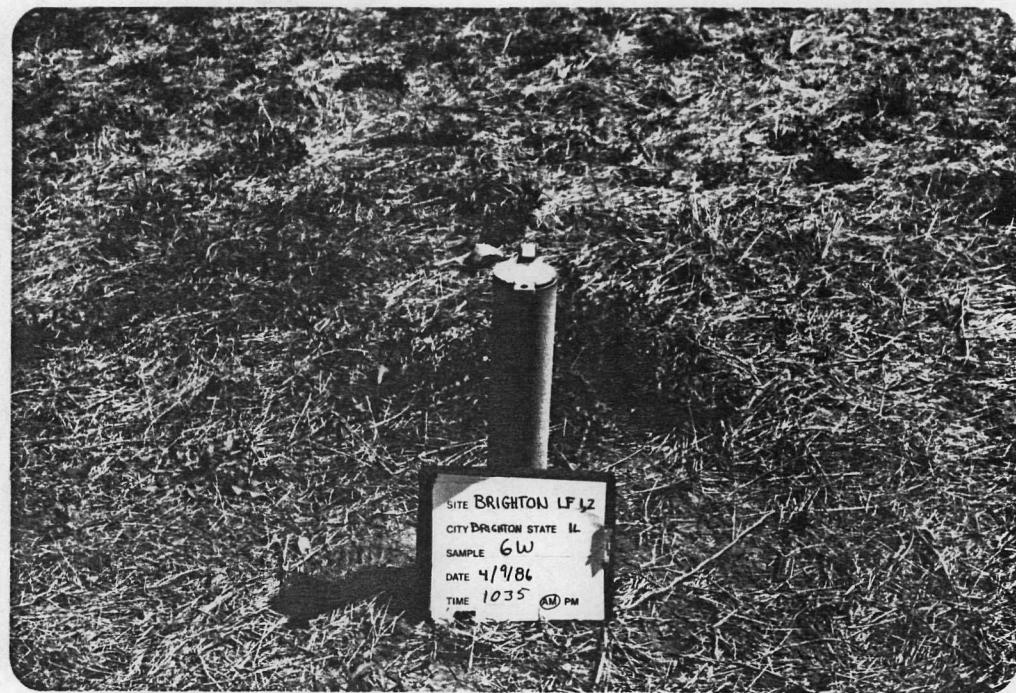
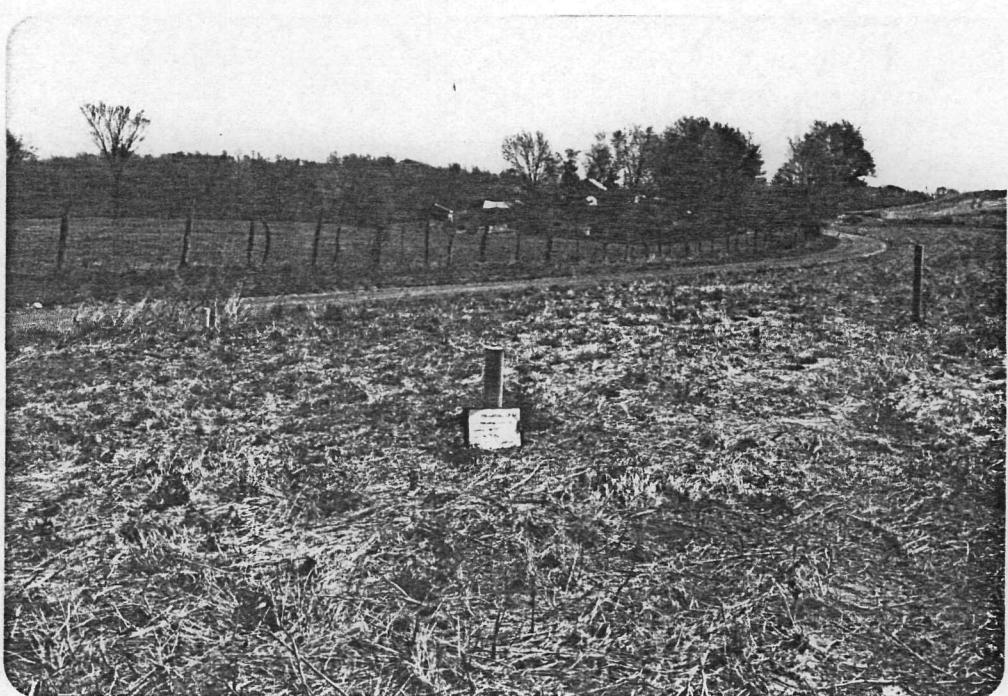
6 W

DESCRIPTION: Well #G 1215 located in farmed field Northwest of Site.DATE 4/9/86TIME 1035 A.M. P.M.DIRECTION: N NNE NE ENE  
E ESE SE SSE  
S SSW SW WSW  
W WNW NW NNWWEATHER sunnymild 55°FSITE Brighton I & IITDD# 05-8410-01C

DESCRIPTION: Same as above from ~ 25 ft.

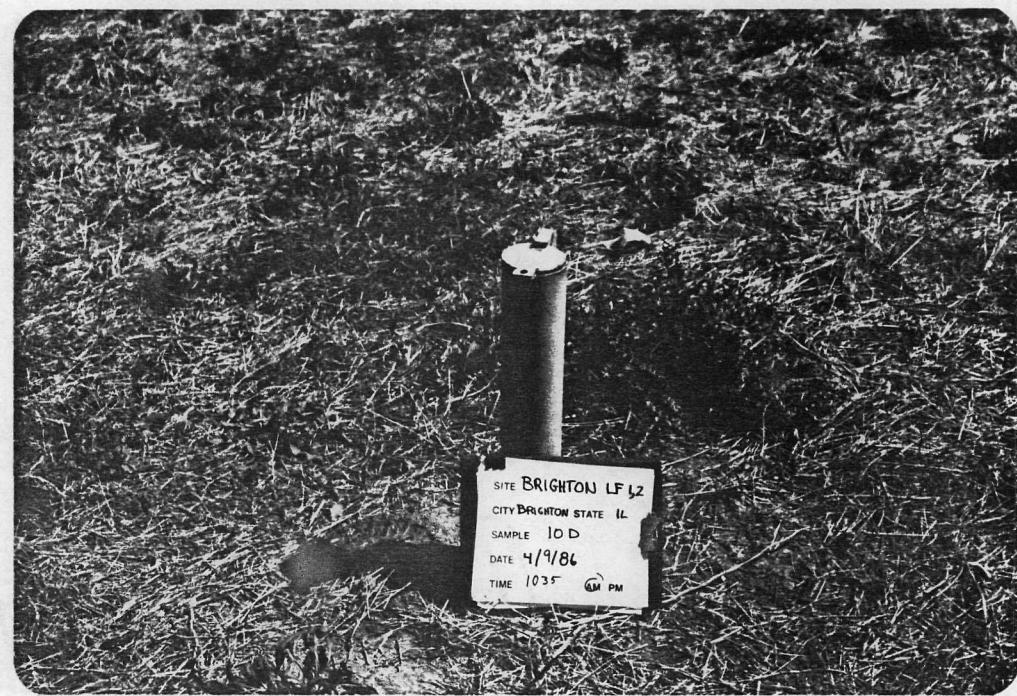
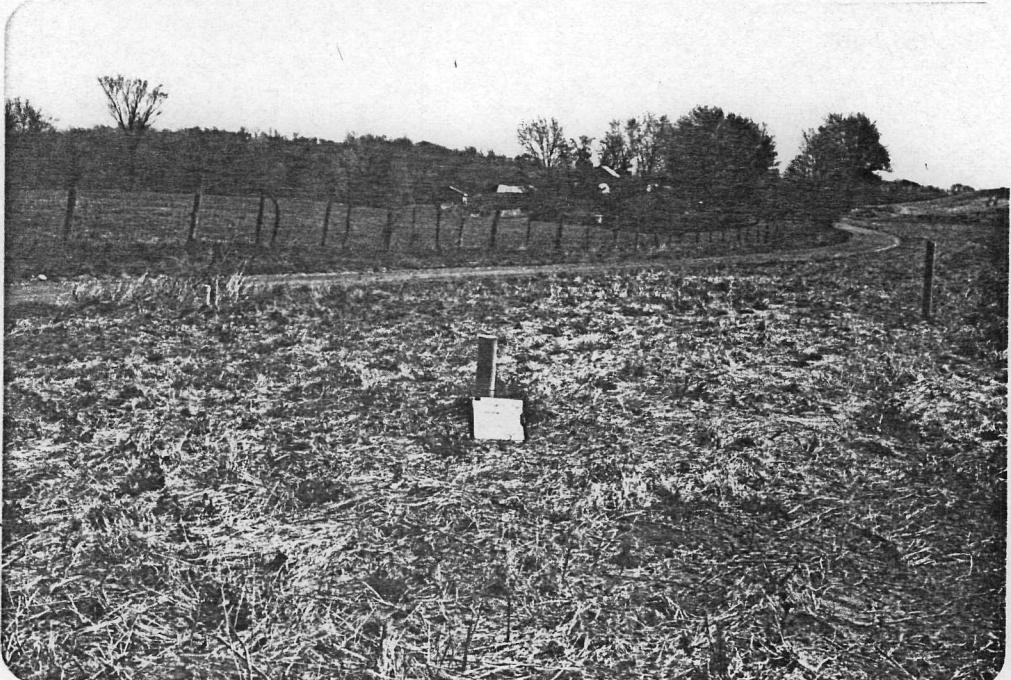
10 D (Duplicate of 6W)

DESCRIPTION: Well - G1215 located in farmed field Northwest of site.DATE 4/9/86TIME A.M. P.M.DIRECTION: N NNE NE ENE  
E ESE SE SSE  
S SSW SW WSW  
W WNW NW NNWWEATHER sunnymild 55°FSITE Brighton I & IITDD# 05-8410-01C

DESCRIPTION: Same as above from ~20 ft.

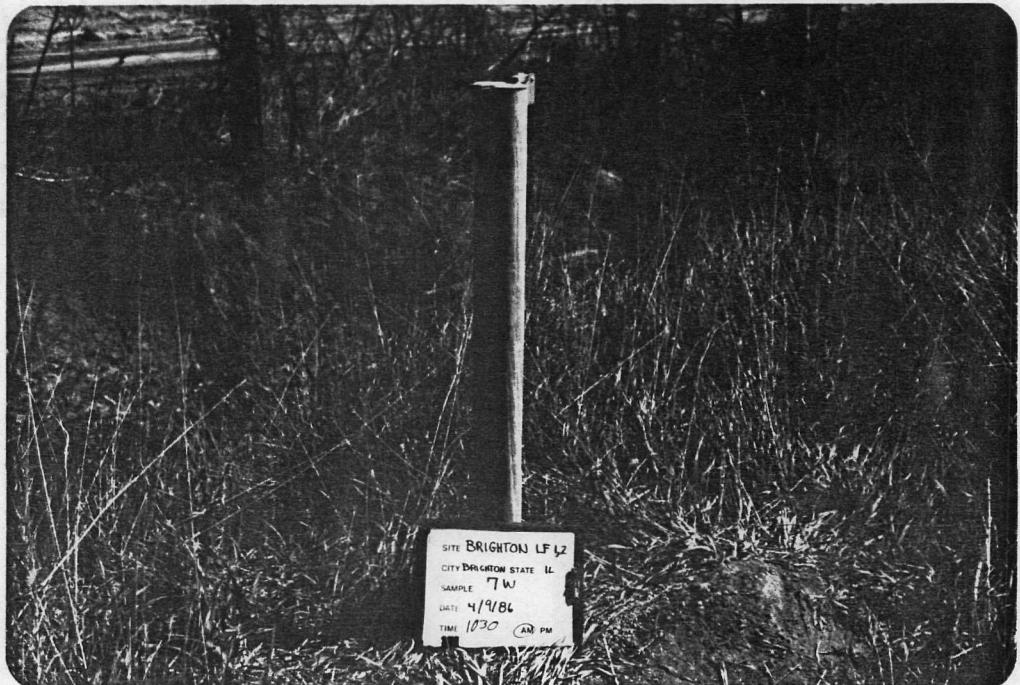
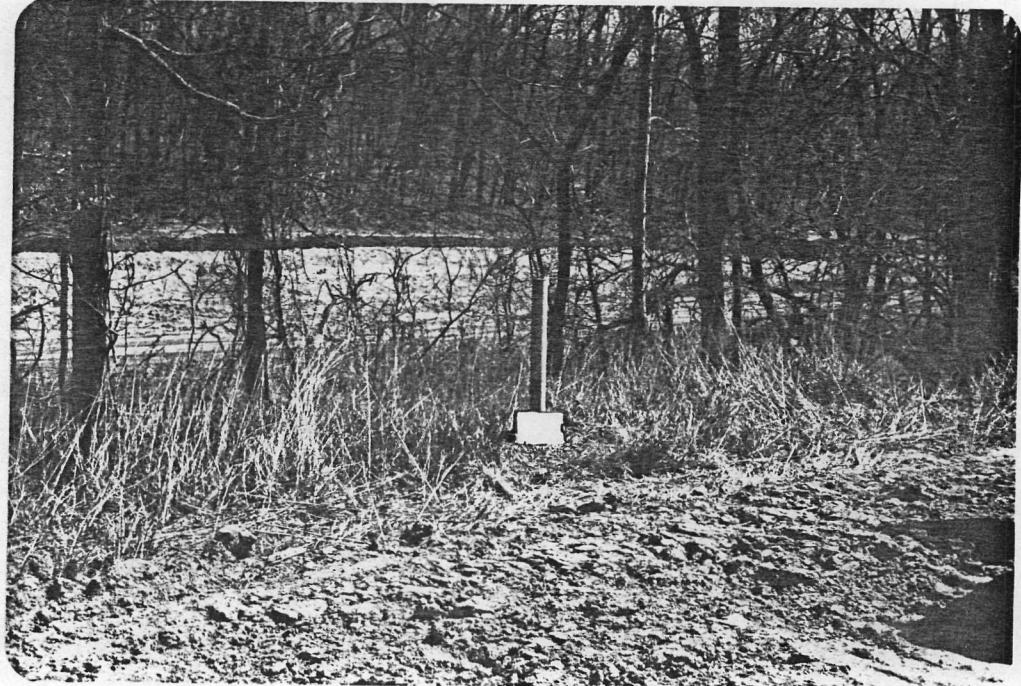
7W

During the FIT inspection 9 wells were sampled. These consisted of 5 deep and 4 shallow wells. No surface water samples were collected. Samples collected from monitor wells G128 and G104 both contained arseric at 13 and 10 ppb respectively. Well G128 also contained nickel at 54 ppb.

G128 is a shallow well and G104 is a deep well. Both are located at the northeast corner of the fill and near the creek. Well G128 is screened at or near the elevation of the creek bed, while G104 is screened well below this level. Groundwater flowing in the zone monitored by G128 should be intercepted by the creek. However, groundwater flowing at the level of G104 is free to migrate away from the site. This deeper groundwater may also enter the bedrock to recharge that aquifer.

DESCRIPTION: Well # G128 s located in the Northeast side of site  
Near CreekDATE 4/9/86TIME 1030 A.M. P.M.DIRECTION: N NNE NE ENE  
E ESE SE SSE  
S SSW SW WSW  
W WNW NW NNWWEATHER sunnymild 55°FSITE Brighton I & IITDD# OS-8410-01C

DESCRIPTION: Same as above from ~20 ft.

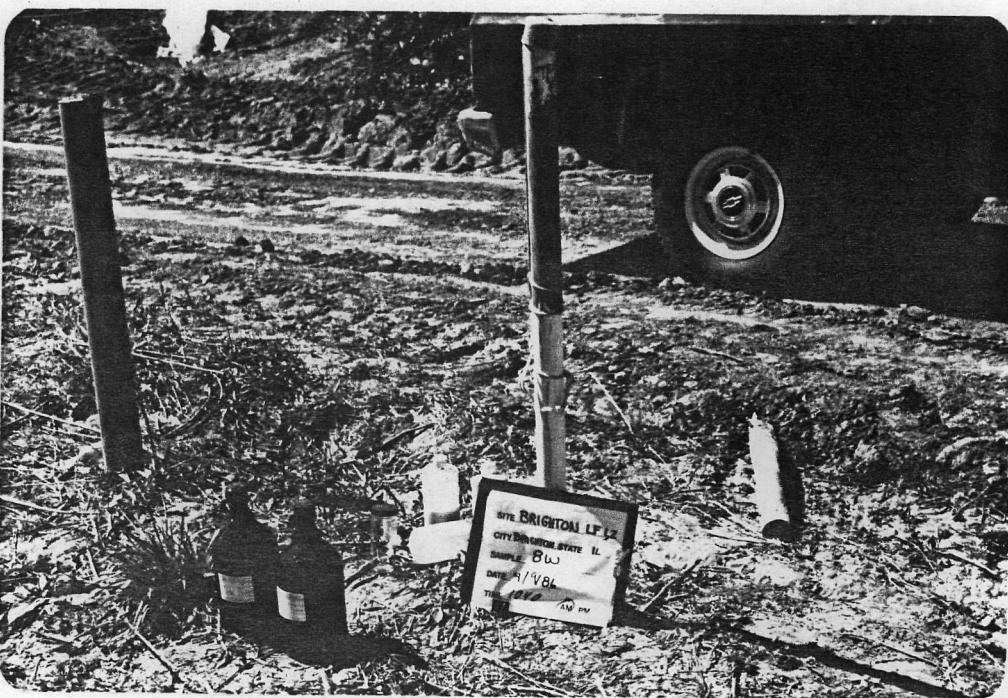
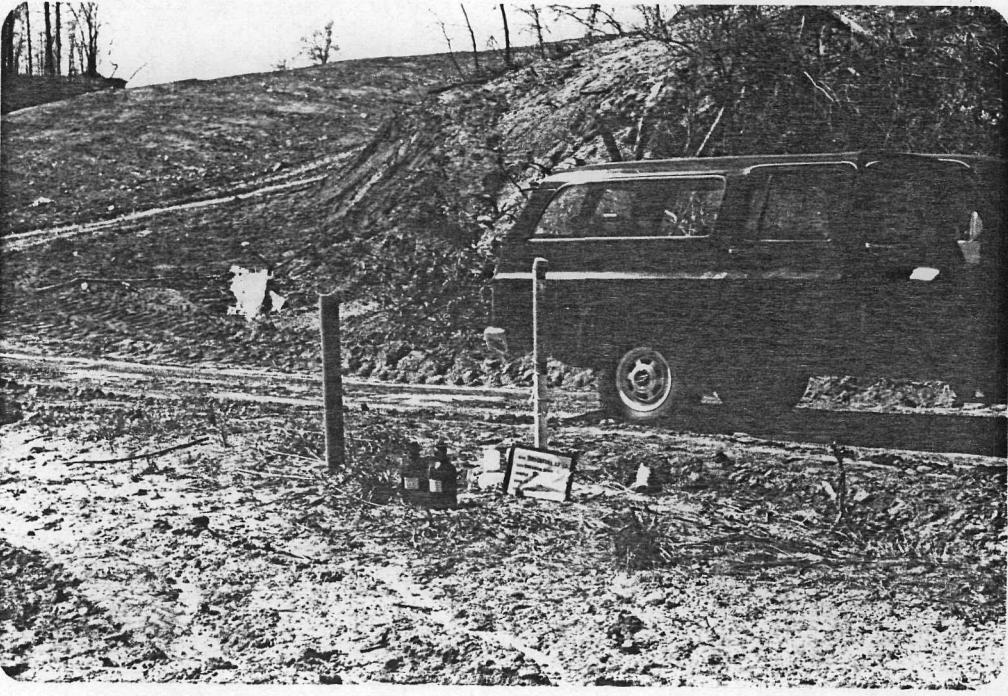
8W

DESCRIPTION: Well #G104d located at Northeast corner below filled area near creek.

DESCRIPTION: Same as above photo from ~20 ft.
